New York State Department of Transportation

Yellow Flag NB22CTW019

BIN: 1065318

Location: Span 157, Girder G6 at Pier 156

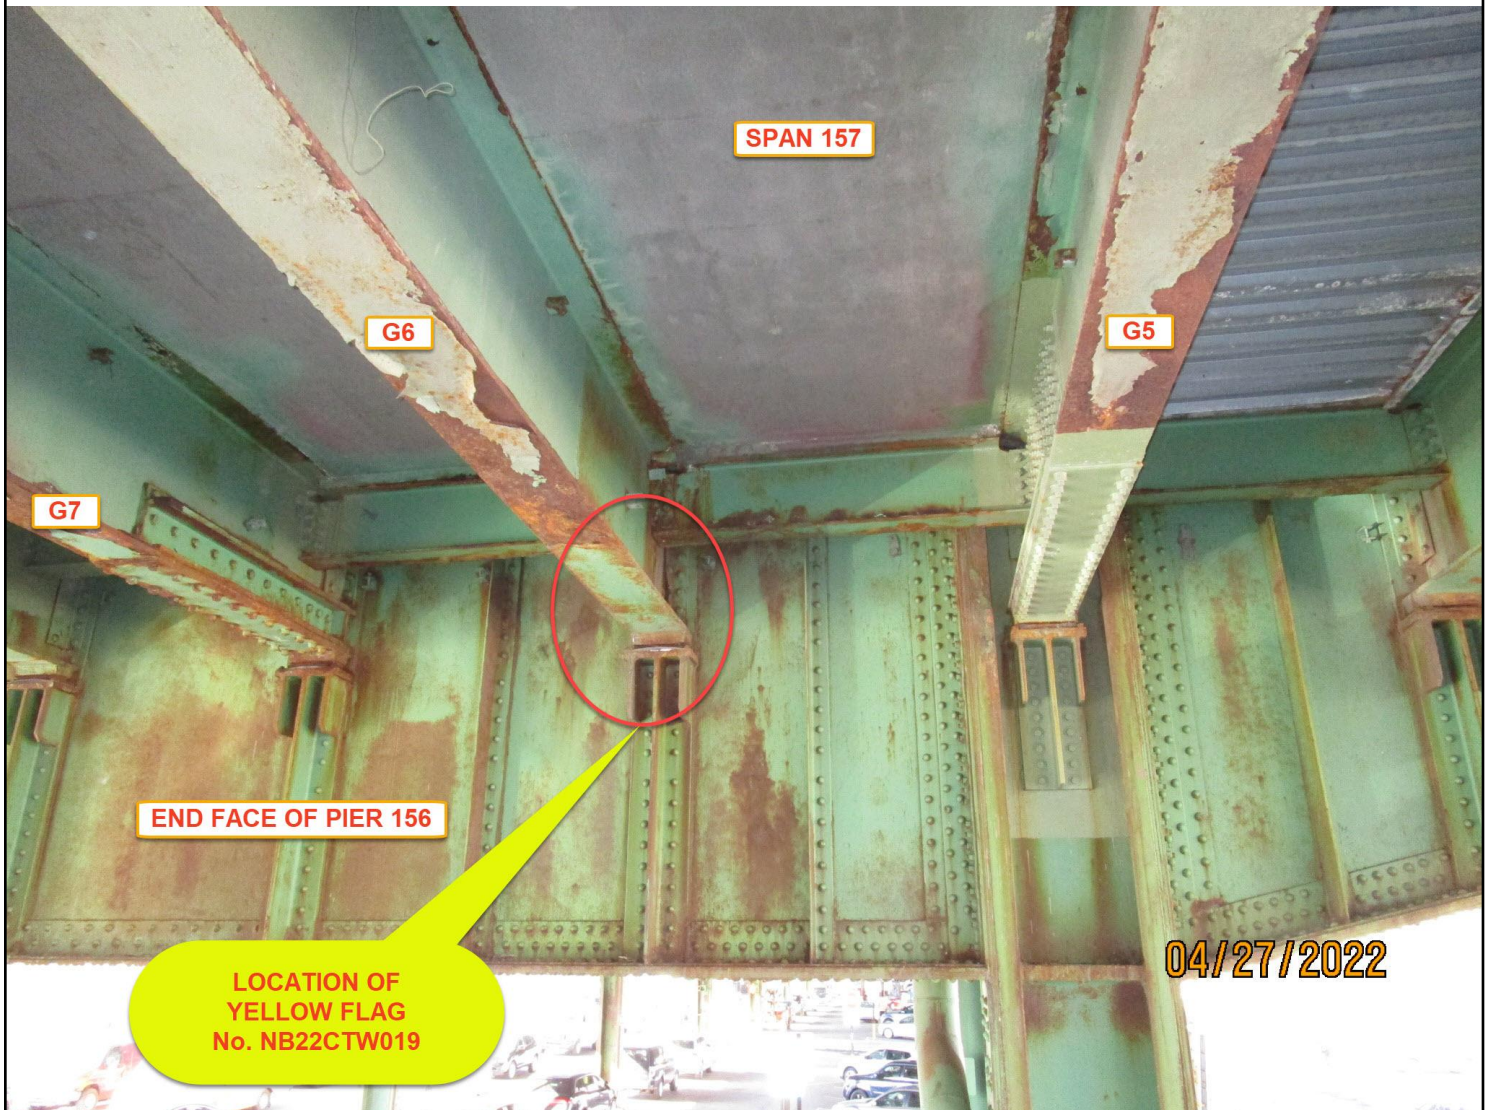
Photo Number: 1

Attachment Description: General view of the flagged location at Girder G6 in Span 157 at Pier 156. Looking Begin.

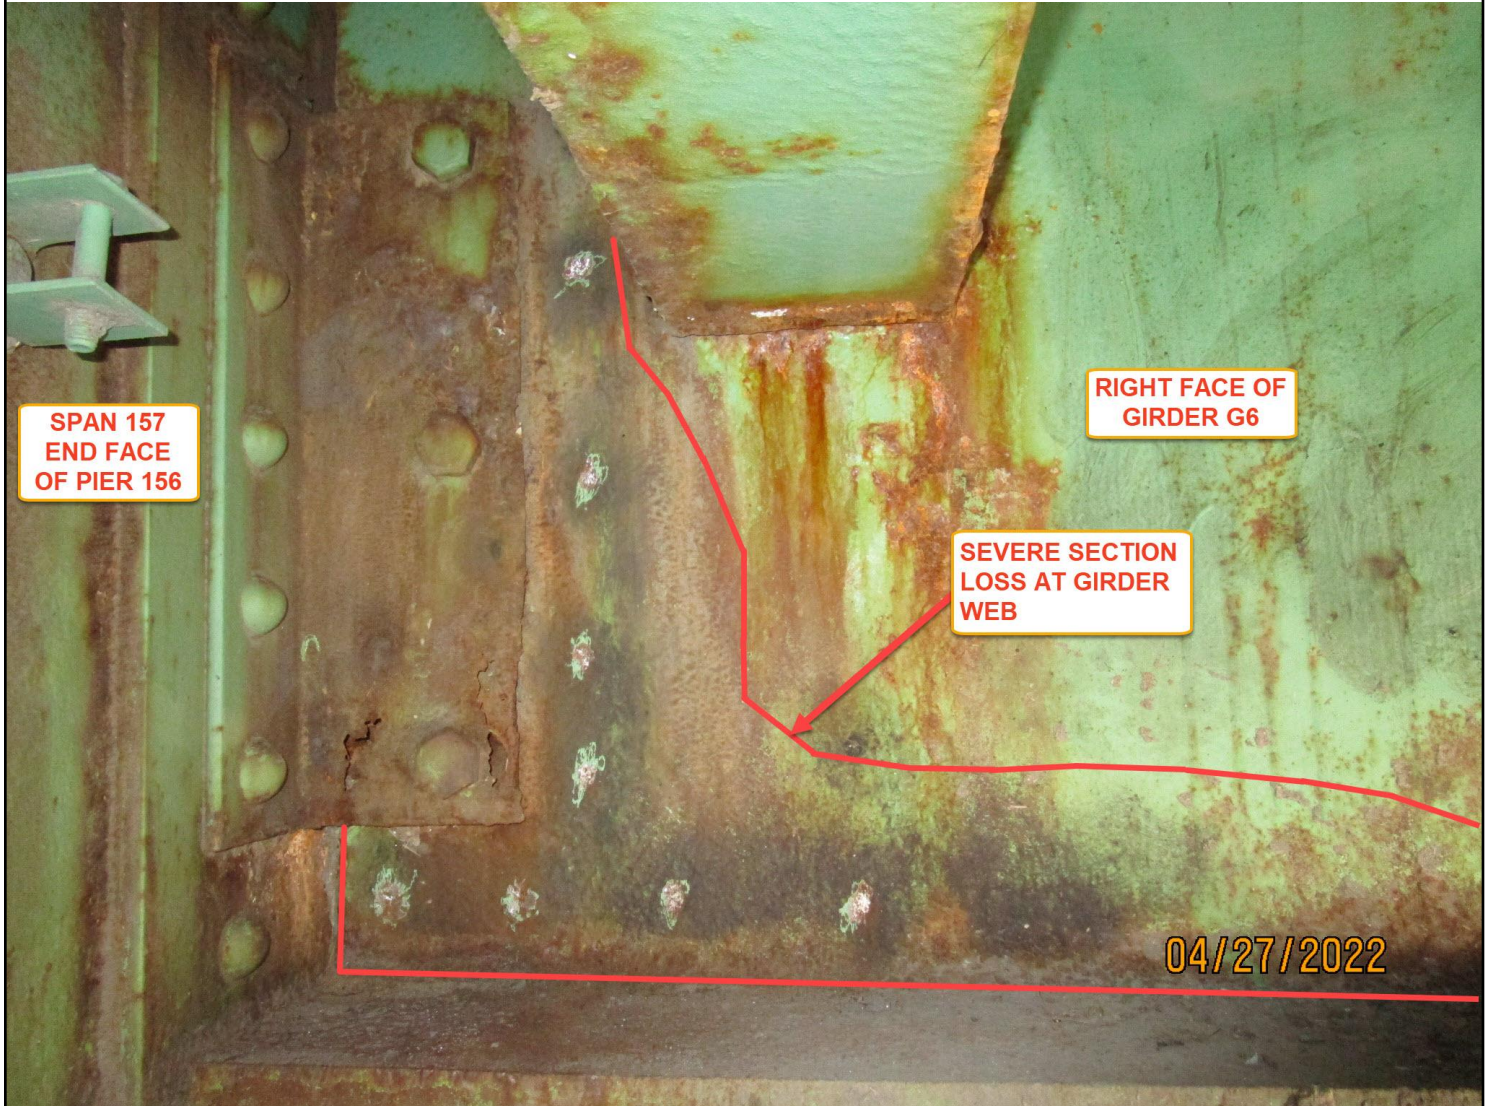
Photo Number: 2

Attachment Description: The right face of Girder G6 in Span 157 at Pier 156. The end of the girder exhibits severe section loss in the lower web above the bottom flange and for the full height of the web adjacent to the connection angle. Looking Left.

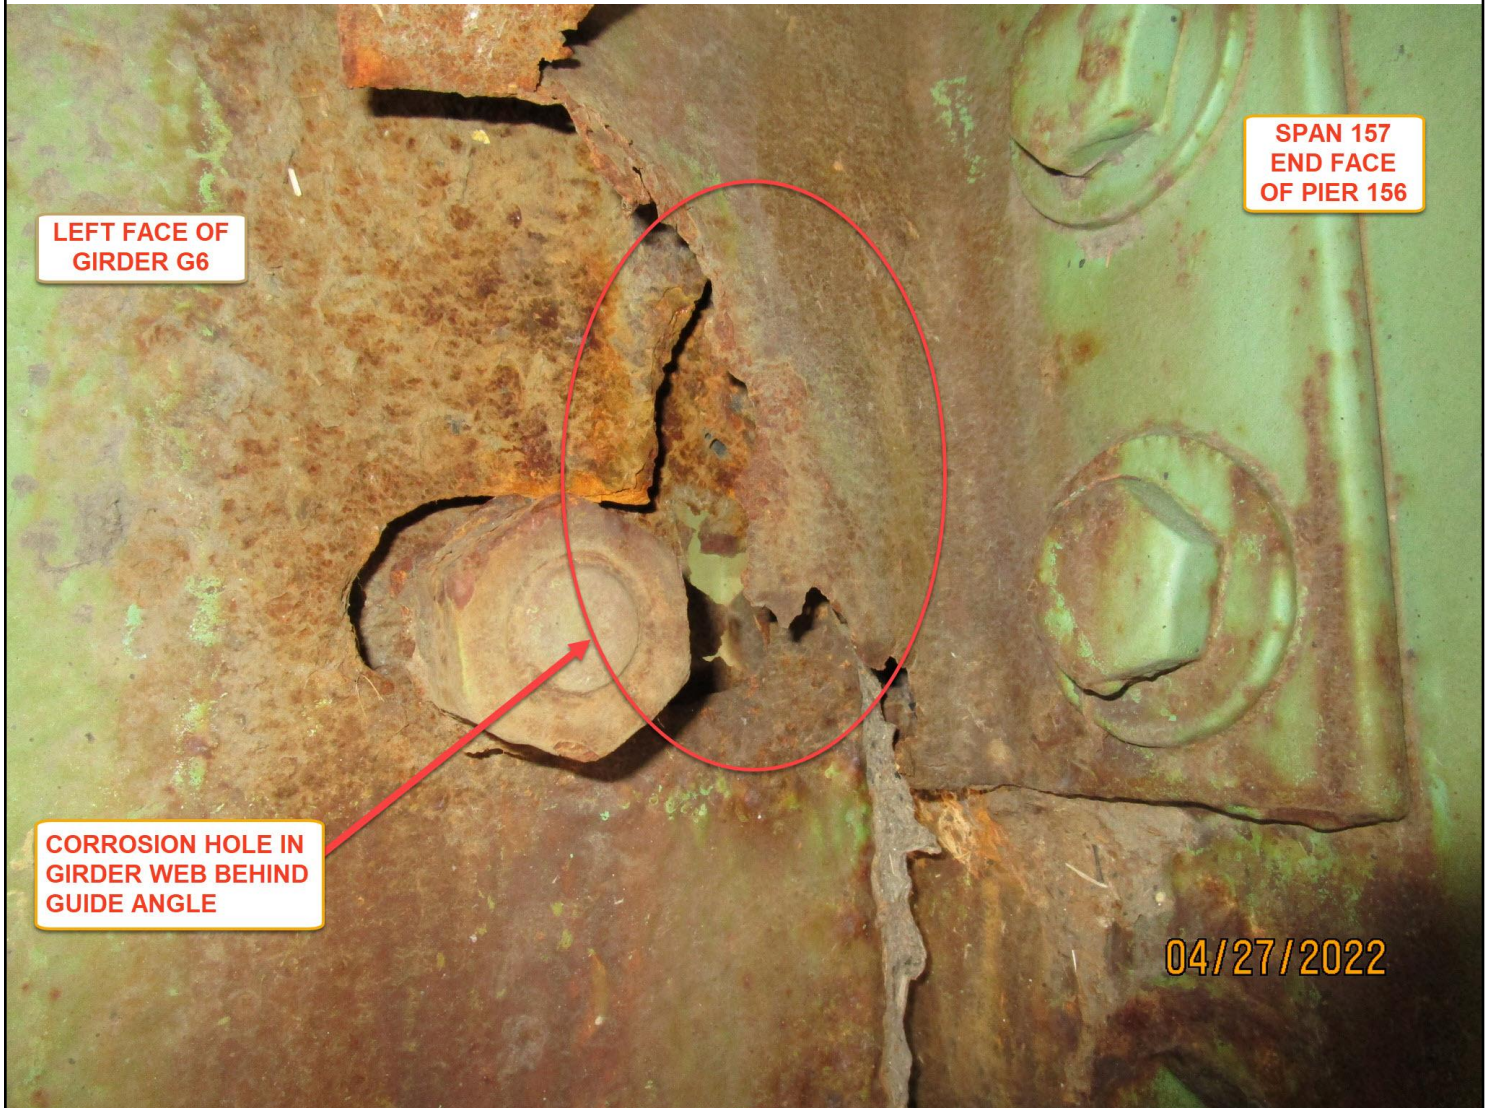
Photo Filename: Photo 3-RA 621_0980.jpg

Attachment Description: The left face of Girder G6 in Span 157 at Pier 156. The end of the girder exhibits corrosion hole in the web behind the guide angle. Looking Begin and Right.

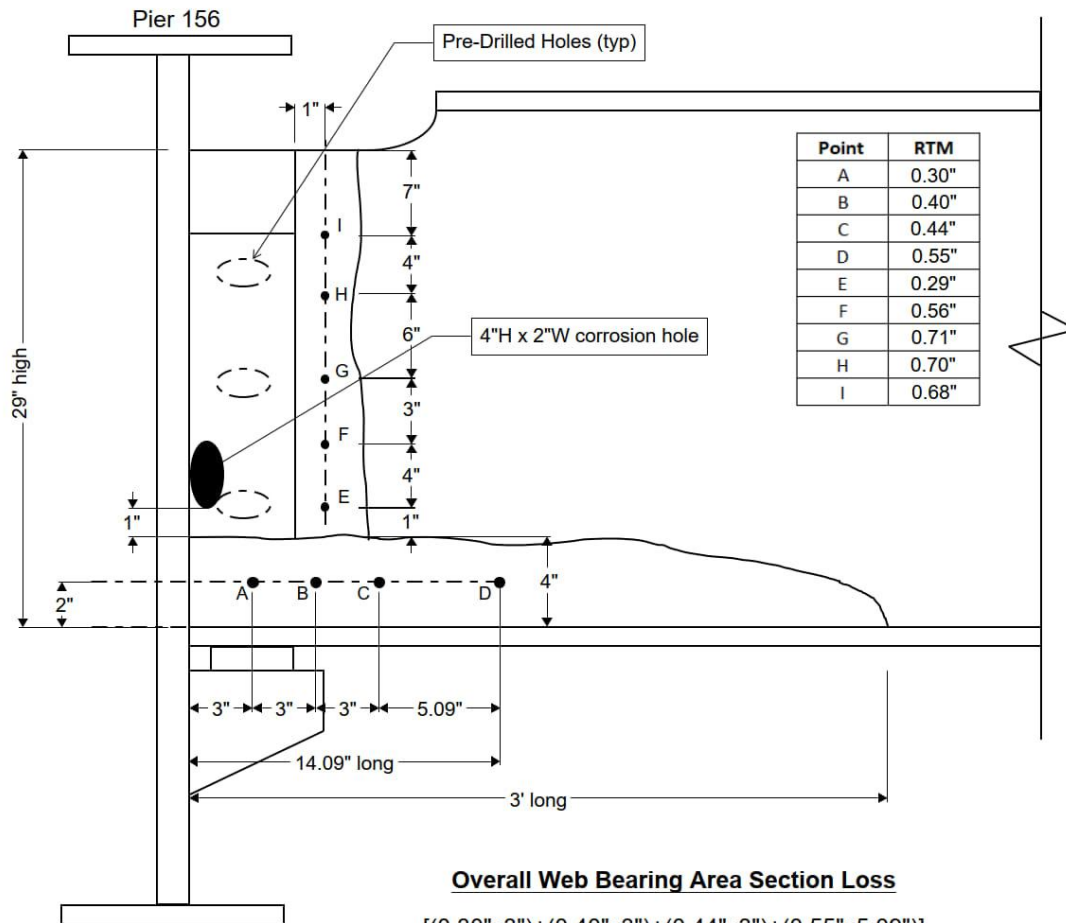
Right Face of Girder G6 Sketch in Span 157 at Pier 156

Description: The end of Girder G6 in Span 157 at Pier 156 exhibits severe corrosion resulting in an overall web bearing area section loss of approximately 44% (previously 46%) and an overall shear web area section loss of approximately 31% (previously 36%) with an average overall localized section loss of approximately 55% for 5" L x 4" H area directly above the bearing below the guide angle (Photo 2). The web of the girder exhibits a 4" H x 2" W corrosion hole approximately 5" from the bottom flange behind the guide angle (Photo 3). This girder is located above an expansion bearing. (Refer to sketch for more details). The condition is the same as reported in the last inspection.

$$\left[1 - \frac{[(0.30 \times 3'') + (0.40 \times 3'') + (0.44 \times 3'') + (0.55 \times 5.09'')]}{11.03 \text{ in}^2} \right] \times 100 = 44\%$$

Overall Shear Web Area Section Loss

$$\left[1 - \frac{[(0.40" \times 4") + (0.29" \times 1") + (0" \times 4") + (0.71" \times 3") + (0.70" \times 6") + (0.68" \times 11")]}{22.71 \text{ in}^2} \right] \times 100 = 31\%$$

- As-built web thickness = 0.783"
- Length of bearing area = $18 \times \text{web thickness} = 18 \times 0.783" = 14.09"$
- Overall bearing area = $14.09" \times 0.783" = 11.03 \text{ in}^2$
- As-built shearing web area = $29" \times 0.783" = 22.71 \text{ in}^2$
- The guide angles at the face of the girder are not shown for clarity
- The remaining area at the lower web beyond 14.09" length exhibits up to 25% section loss
